RESEARCH AND INVESTIGATION INTO THE PERFORMANCE OF RAIN WATER TANKS IN BUSHFIRES

A recent research project involving the Bushfire Cooperative Research Centre (Bushfire CRC) and the CSIRO has revealed that different types of rainwater tanks can play an important role in defending houses against the threat of a bushfire.

The research project was conducted in the NSW Rural Fire Service experimental research facility at Mogo on the south coast of NSW, at what is believed to be the only bushfire simulator of this type in the world.

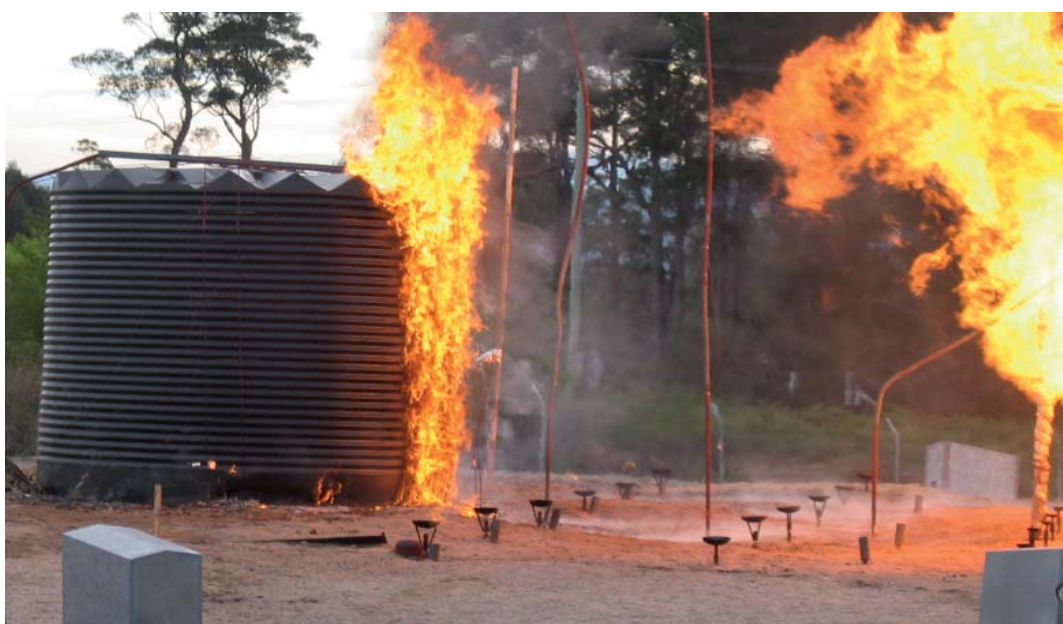
TESTING OF POLYETHYLENE RAINWATER TANKS

Polyethylene tanks suffered considerable structural distortion during simulation of a bushfire passage. The tanks demonstrated structural deformation during the 30 minute flame exposure, resulting in the tank splitting itself & melting down. Polyethylene tanks were at risk of total failure when adjacent combustible items are present, in the form of forest litter, fences or other polyethylene tanks.
